IMPROVING IMMO COIL QUALITY VIA SIX SIGMA

Di Zhang^{1,2*}, JinQuan Zhang²

Abstract: This paper takes the Immobilizer antenna (referred to as IMMO) in J Company's keyless entry and start system (Passive Entry and Passive Start, PEPS) as the research object. Using the Six Sigma method, a systematic analysis and improvement were conducted to address the issue of high C/1000 (defects per thousand units) of this component. Through the five stages of Define, Measure, Analyze, Improve, and Control, the key process variables affecting product quality were identified and optimized. The research results show that by improving the winding fixture, optimizing the heating temperature control, and introducing insulation detection between turns, the C/1000 of the IMMO antenna was significantly reduced, thereby improving product quality and customer satisfaction. The research in this paper provides useful references for the quality management of similar products in the automotive electronics industry.

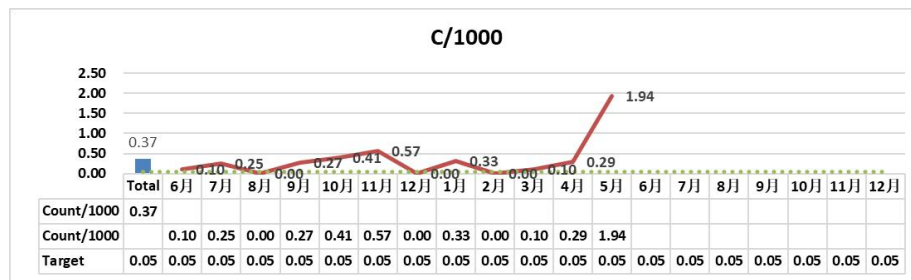
Figure 1 Trend Chart of the Problem

During the key-offline learning process at the assembly plant, the IMMO coil communicates with the key using a 125kHz low-frequency signal. In case of occasional failures, the learning process fails due to inability to resonate, and the vehicle cannot learn the key. The failure rate is 1.94 C/1000, and the performance is deteriorating. See Figure 1 for the trend chart of the problem. The IMMO coil's drawing specifies the inductance value specification as $162 \pm 2\% \mu\text{H}$ @ 125kHz. The measured value of the faulty part is 19.20 μH , indicating a low inductance. This coil is from a certain manufacturer. Therefore, the research scope of the project is the supplier's production process.

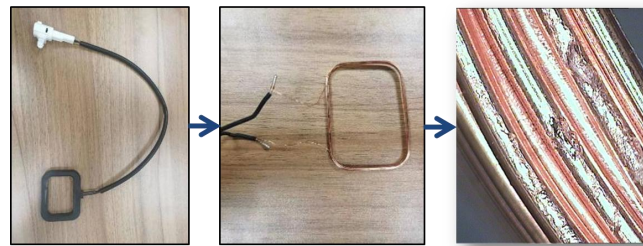
Figure 2 Location of the Injury

At the supplier's site, using the LCR measuring instrument (1V, 125kHz), the problem points were identified one by one: the insulation layer was damaged in the two outermost turns of the coil from the edge of the housing. The location of the injury is shown in Figure 2.

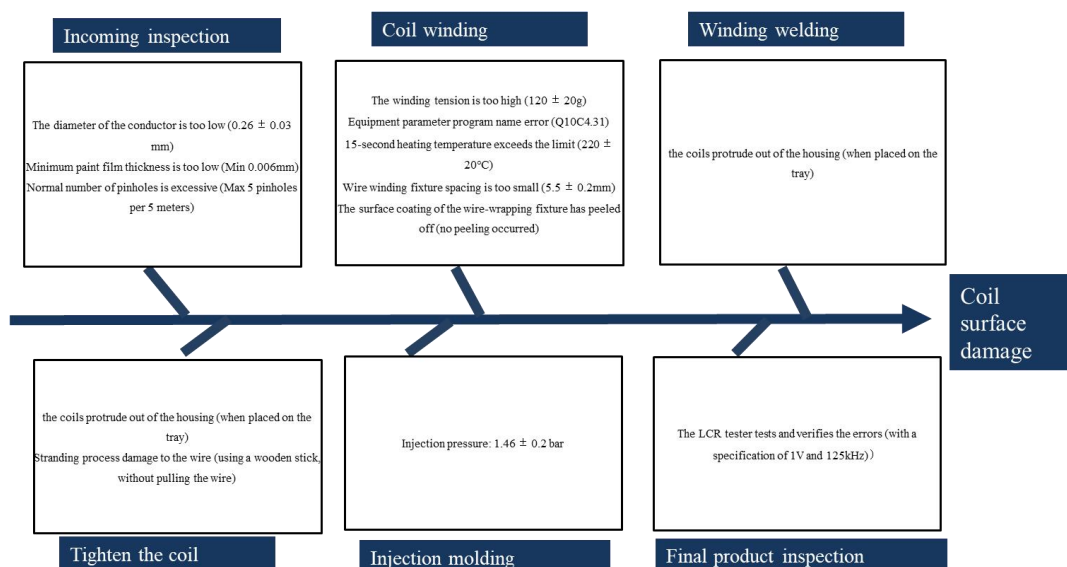
Figure 3 Fishbone Diagram

Firstly, review the existing process flow, such as "incoming material inspection → winding → assembly and foot welding → injection molding → low-pressure injection molding → final product inspection", and identify the key processes with high impact. Use the SIPOC tool to analyze the influencing factors of each key process of the coil. The fishbone diagram aids in organizing complex information and offers a structured approach to decision-making and actual planning of maintenance interventions[8]. Figure 3 is Using the fishbone diagram to brainstorm and list the factors with high impact.

Then, the causal matrix table is used to evaluate the weight of each input variable on the defect. By analyzing the influence degree of each input parameter on the coil surface, seven key factors are determined: 1. Excessive winding tension, equipment program error, line damage, fixture coating off, low film thickness, too many pinholes, and LCR tester test error. Combined with the results of on-site production evidence investigation, as shown in Table 2, the remaining three impact factors after screening have insufficient evidence, and the three impact factors are in poor state, all of which need further study on process capability performance.

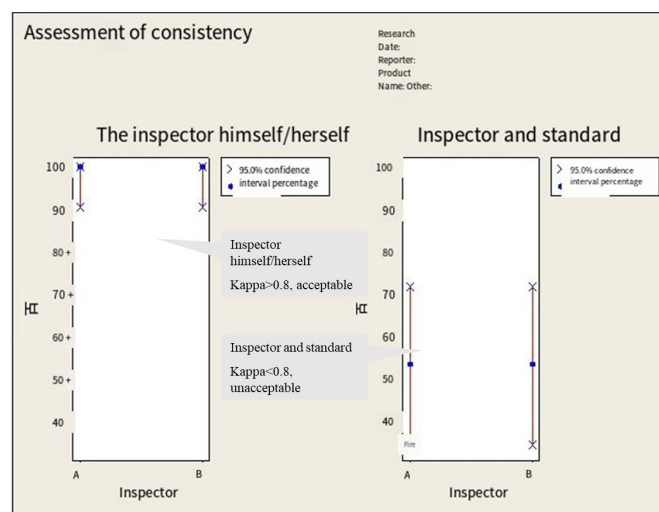
Figure 4 Assessment of Consistency

Among them, in the LCR tester process, 30 measurement objects were prepared (20 coils with varying degrees of damage and 10 good coils), and two operators conducted repeated measurements twice, with a total of 120 tests. The misjudgment rate of the equipment for faulty parts was 47% (NG judged as OK), and the Kappa value was less than 0.8, making the measurement system unacceptable, as shown in Figure 4. The primary measure for fault analysis is to protect the customer, and it is urgent to implement a new detection method for the current situation. After benchmarking with the same industry, an additional high-voltage test was added, using a 2900V high-voltage tester (based on 70% of the 4200V insulation voltage of the enameled wire) to detect energy loss. The MSA verification Kappa value was greater than 0.8, which was acceptable.

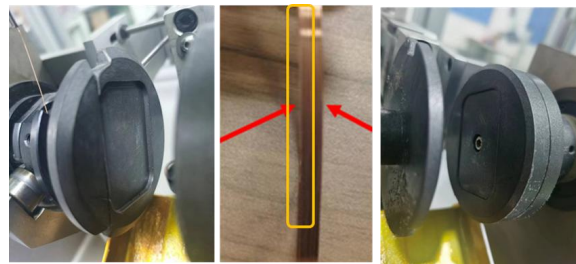
Figure 5 The Coil Damage Point and the Fixture Position Correspond

After checking the surface coating of the winding fixture, it can be clearly seen that there is wear at the contact position of the coil. The outermost anti-wear layer of the fixture has been scratched. And touch by hand, can obviously feel the position of the contact coil is rough and not smooth. The high voltage tester (2900V) was used to continue to check the bare coil. The coil produced by the fixture was 3170 PCS, and the faulty parts with insufficient voltage tolerance were 6 PCS. Observe its air discharge position, which is located in the left and right section of the coil in Figure 5 below, which is exactly the contact surface between the coil and the fixture.

Further process confirmation is carried out to confirm that the surface coating of the winding fixture has not been regularly inspected since it was put into use in 2021, there is no relevant maintenance requirements, and there is no life management.

Regarding the problem of the wire clamping fixture falling off, a new fixture was immediately customized. The produced coils with the new fixture were analyzed for data. The reliability of the fixture was verified by analyzing the change in the defect rate. This fixture was identified as a spare part for the winding machine equipment. A maintenance plan was formulated, and a replacement frequency was determined. The coating condition of the production coils was confirmed daily at the start of each shift. Additional spare parts were added, and the production clamps were required to be replaced compulsorily every 6 months and re-coated at the factory. Other devices in contact with the enameled wire, such as the lead-out pins, felt pads, and idler pulleys, were expanded laterally to increase protection and maintenance.

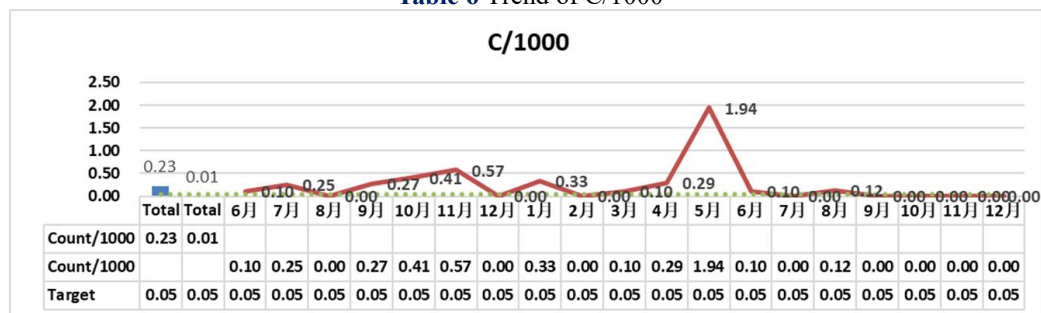
Table 6 Trend of C/1000

With the newly produced modified components, the failure rate during loading has dropped to nearly 0, showing a significant improvement. The trend of failure data is shown in Table 6.
